1993 NORTHEASTERN MT COAL MAINTENANCE PROJECT

DSL - AMRB No. 93-M03

FINAL REPORT

SPECTRUM ENGINEERING

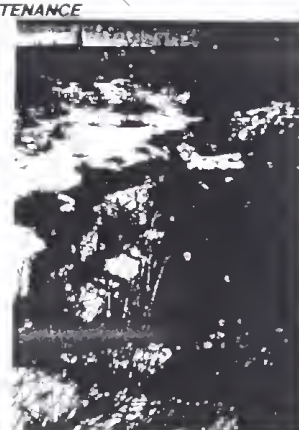
Picture 2 shows subsidence hole B looking Northeast.

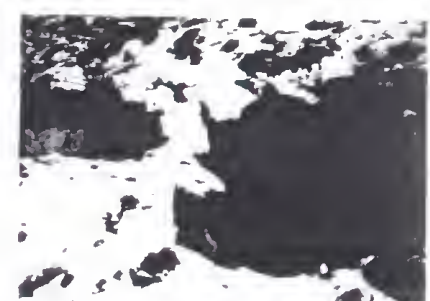
3 CLOSE-UP VIEW OF SUBSIDENCE HOLES A AND B.
